historic	THE WALKE	R HOUSE			
other	THE WALKE	KIIOUSE			
2. Location					100 Sept. 100 Se
street and number	r 10541 CONNE	CTICUT AVENUE (for	mally 10422 Armory Avenu	ie)	_ not for publication
city, town	KENSINGTO	95)			vicinity
county	MONTGOME	RY

7. Description	Inventory No. M: 31-6-3
Condition	
excellent deteriorated	
good ruins	
x fair altered

## Maryland Historical Trust Maryland Inventory of Historic Properties Form

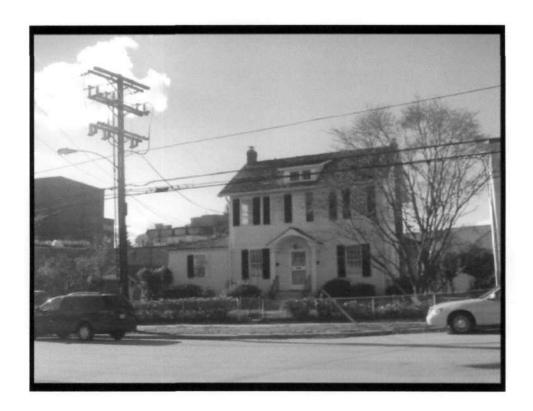
#### THE STRUCTURE

This 2 & 1/2 storey Federal Revival includes a single storey small wing built in 1955 to the left of the front facade conatining a single 1/1 shuttered window and low hipped roof. The original exterior walls of horizontal clapboards have been covered with a roll siding material. The roof is wood shake and includes centered shed dormer and chimney flues at each end.

#### THE EAST AND FRONT FACADE DESCRIPTION

The main facade has four second floor shuttered 1/1 windows and two first floor 1/1 shuttered windows which are symetrically placed around the doorway by two columns topped by a wide triangular pediment. This structure is set on a high foundation with the emphasis on the entrance bay in the middle of the house for a classical effect.

The east, or front, façade is three bays on the first story and four on the second. The first story features a center door sheltered by a barrel-vaulted porch with a front-gable roof supported by two columns. Twelve-over-twelve windows fill the end bays. The four second-story bays also contain twelve-over-twelve windows. All of the windows on both stories have louvered shutters. A simple box cornice finishes the foot of the shallow, wood shingle roof. A small shed dormer breaks the front slope of the roof at the centerline and contains a pair of three-over-three fixed-pane windows.

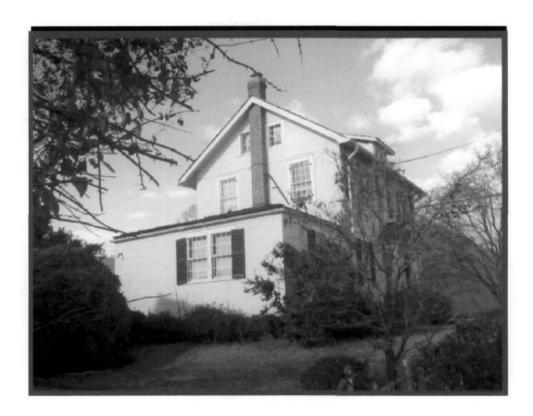
#### THE SOUTH SIDE FACADE DESCRIPTION

The south side facade presents a small. one stiry wing having a single opening of a double window frame with a 1/1 shuttered window.

The second floor of the south side window has two symmetrically placed 1/1 windows each side of the exterior brick chimney.

Two smaller windows hug the chimney stack in the attic gable. The chimneys have both flues and caps.

The south gable end of the main block has a small exterior chimney centered on the elevation; it passes through a deep overhanging eave and terminates with a corbelled cap. The second floor of the south end features two twelve-over-twelve windows. There are no shutters, although it appears that pintles are in place to receive them. Two small, four-over four attic windows flank the chimney in the upper gable.

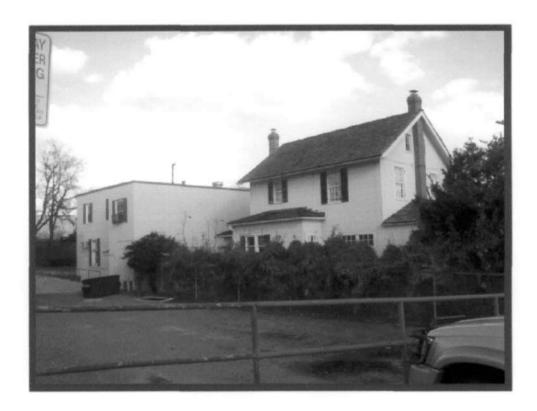
#### THE WEST SIDE FACADE DESCRIPTION

The west side facade and rear of the house has a small, grafted, one storey bump out with a paired, shuttered window protected by a hipped roof.

The first floor of the main structure's west side has an unshuttered double window frame. In the west side's small 1955 attached wing has a 1/1 window, similar in placement to the front facade.

The west, or rear, elevation of the main block features a very shallow, two-bay, one-story wing with a hipped roof; the wing covers the center and left bays of the elevation. The south bay of the first floor of the main block is pierced by paired, six-over-six windows. The second story of the main block has two asymmetrically-placed windows, both with louvered shutters. The window to the right is larger, twelve-over-twelve; the window to the left is smaller, perhaps six-over-six (photo unclear). The shortening of this second-story window indicates that the wing is original. The west side of the wing contains paired, one-over-one windows, set off-center, with shutters. The south side of the wing appears to have a door, although the photograph is not clear. The north side of the addition was not visible.
